PEST CONTROL SERVICE LOGBOOK

Integrated Pest Management — Commercial Food Facility

Sydney Food Co Pty Ltd

January – May 2026

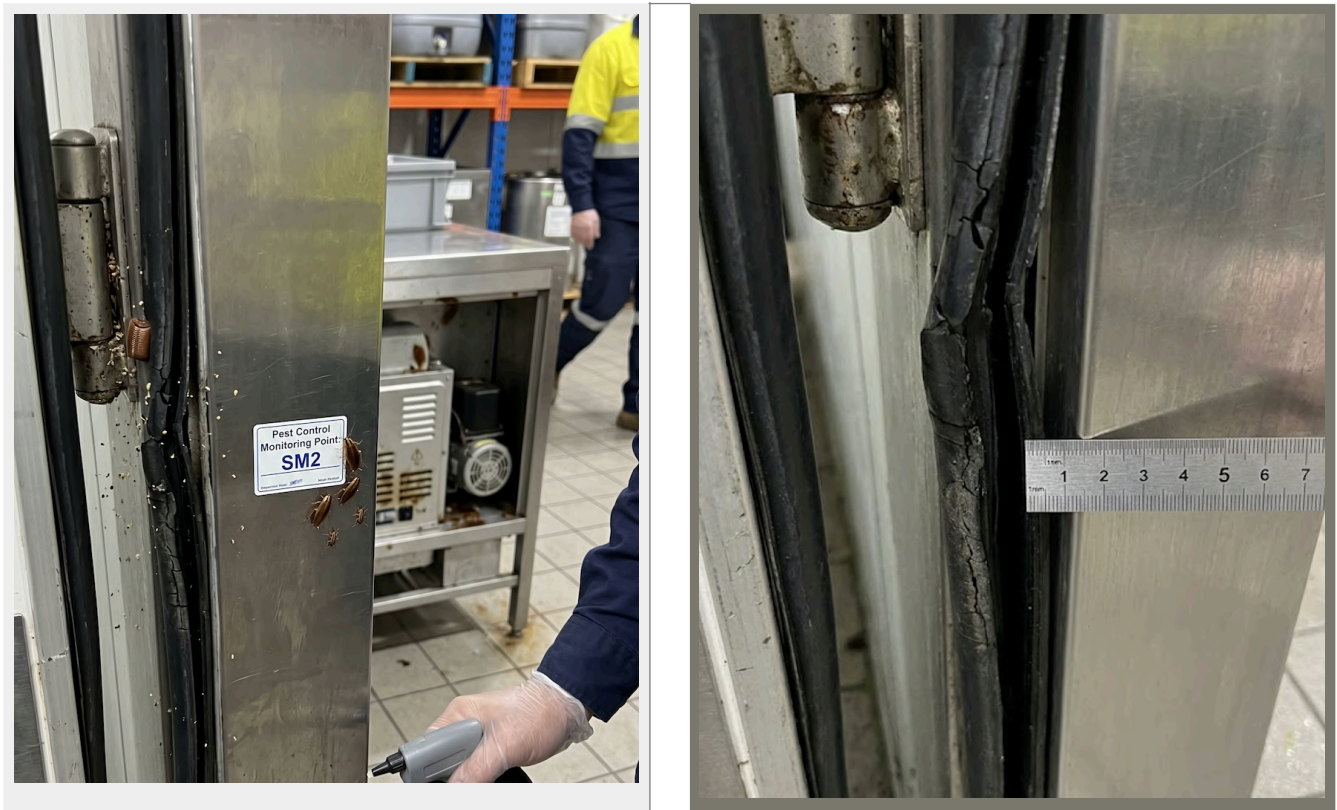
Kitchen

Devices Checked	Evidence Observed	Activity Level	Technician Notes
SM2	11 German cockroaches on SM2. Egg case on cold room door hinge.	MODER- ATE	Active harbouring behind dishwasher motor housing and cold room hinge. Food zone — immediate gel treatment applied.

△ Recommendation: Cold room door seal cracked — 10mm gap along hinge allowing cockroach ingress. Replace door seal / brush strip. Temporary food-safe sealant acceptable as interim measure.

Severity: HIGH Responsible: Site — David Chen

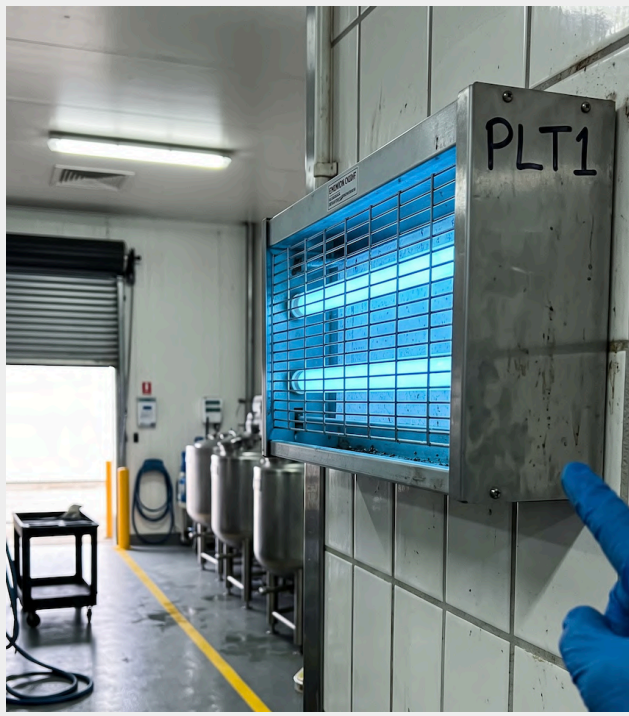
Production Floor			
Devices Checked	Evidence Observed	Activity Level	Technician Notes
PLT1, PLT2	PLT1: 8 house flies, 2 blowflies. SM5, SM6 clean.	LOW	Fly pressure consistent with loading dock proximity. ILT catch within acceptable range.
<p>⚠ Recommendation: Drain D3 near filling machine has visible organic film and mild odour — potential drain fly breeding site. Mechanical clean and biological drain treatment (Bactoil) required before next visit.</p> <p>Severity: MEDIUM Responsible: Site — Facilities team</p>

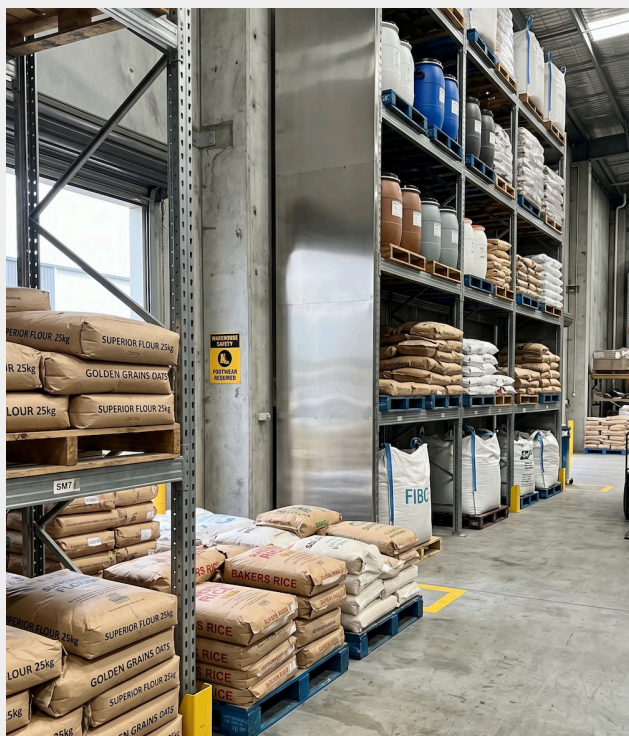
Devices Checked	Evidence Observed	Activity Level	Technician Notes
SM7	SM7 clean. No stored product insect evidence.	NONE	Racking and product packaging inspected. No evidence of moth or beetle activity.

✓ No recommendations this zone.

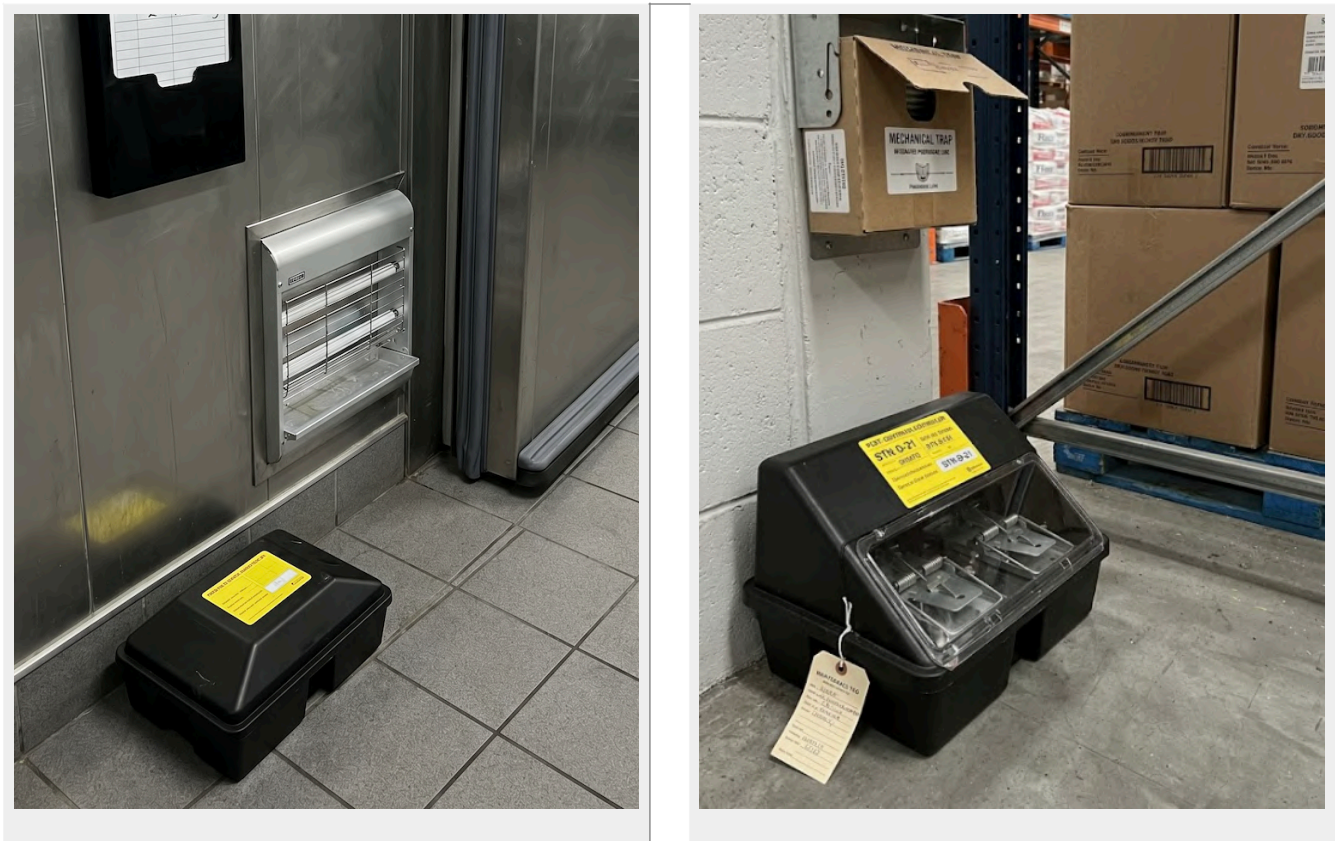
Cool Room / Freezer			
Devices Checked	Evidence Observed	Activity Level	Technician Notes
CR1, CR2	Zero catch on both stations. No pest evidence.	NONE	Temperature 2°C. No pest evidence. Door seals in good condition.
✓ No recommendations this zone.

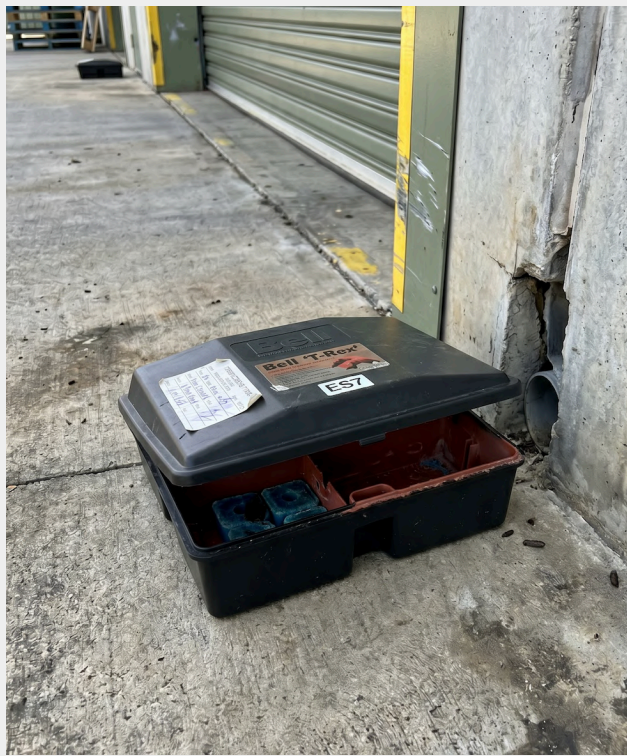
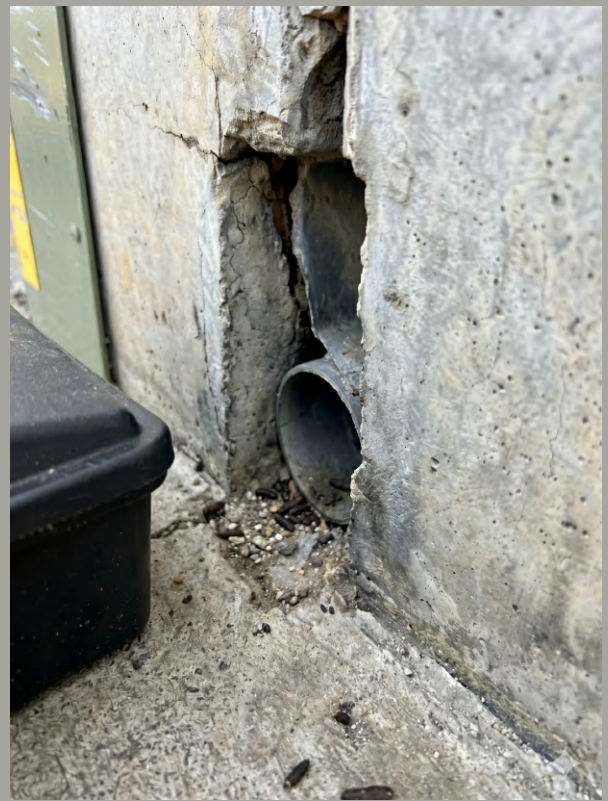
External Perimeter (North & South)			
Devices Checked	Evidence Observed	Activity Level	Technician Notes
ES1–ES8	ES7: bait fully consumed, fresh droppings at base of station.	HIGH	Significant rodent activity at ES7, south wall near loading dock. Drainage gap identified as entry point. Bait replenished this visit.
<p>⚠ Recommendation: Drainage gap at south wall / loading dock junction — approx. 40mm wide x 300mm. Active rodent entry point. Fill with concrete or pest-proof mesh immediately. Source of ES7 pressure. Must be actioned before next visit.</p> <p>Severity: URGENT Responsible: Site — Facilities team</p>

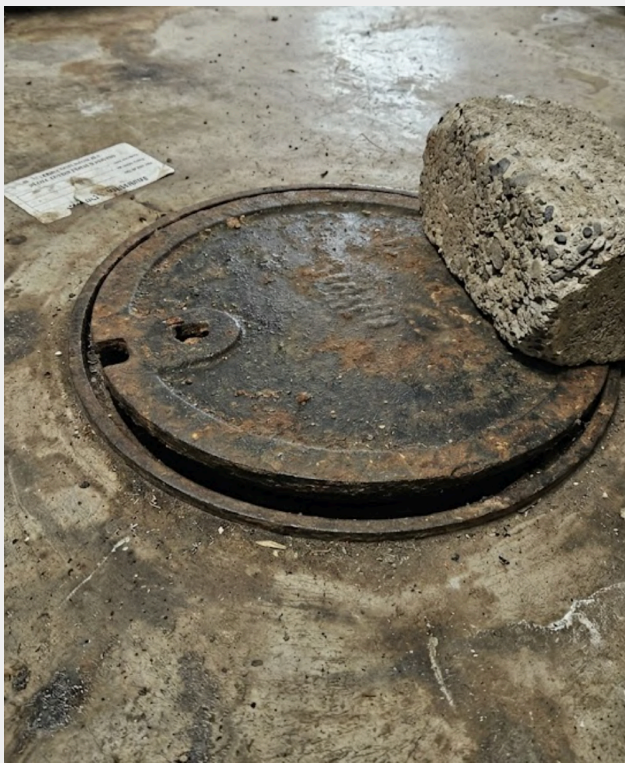
Basement / Plantroom			
Devices Checked	Evidence Observed	Activity Level	Technician Notes
SM8	SM8 clean. No cockroach evidence.	NONE	Sewer access hatch noted — lid not sealing correctly. Weighted closed at end of visit.
<p>⚠ Recommendation: Sewer access hatch lid not sealing — visible gap around edge, cockroach harbourage risk. Fit rubber gasket to hatch lid perimeter. Ensure hatch is weighted closed at all times until resolved.</p> <p>Severity: MEDIUM Responsible: Site — Facilities team</p>
